## **WUFI Analysis: SlopeShield Plus SA vs. Ice Barrier Membrane** *for Steep Slope Roof Applications*

### **WUFI Analysis Overview**

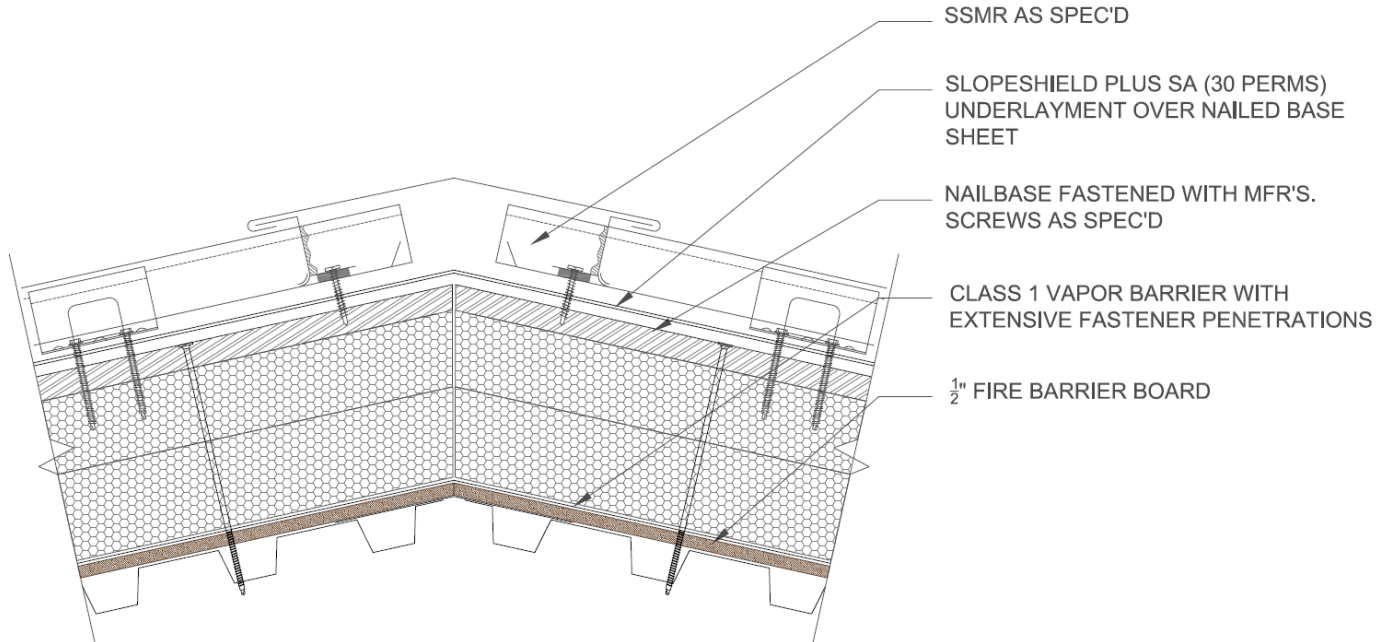
**Scenario 1: Gymnasium, Billings, MT**

This scenario measured the 10-year hygrothermal performance of a large gymnasium.

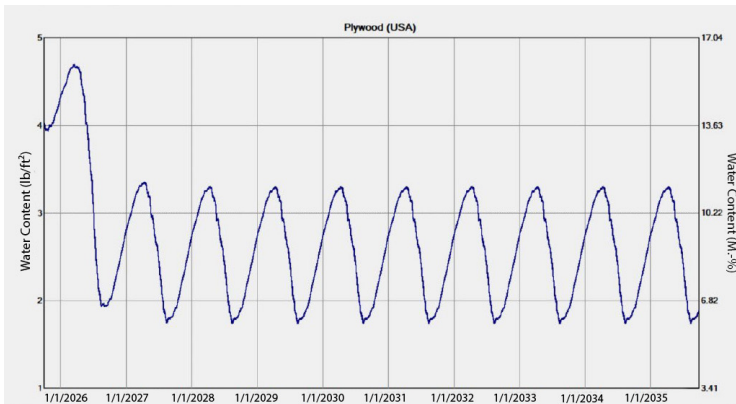
**SlopeShield Plus SA**

Moisture levels dropped and stabilized quickly when SlopeShield Plus SA was part of the assembly (3.1–3.4 lb/ft<sup>3</sup> within 1 year).

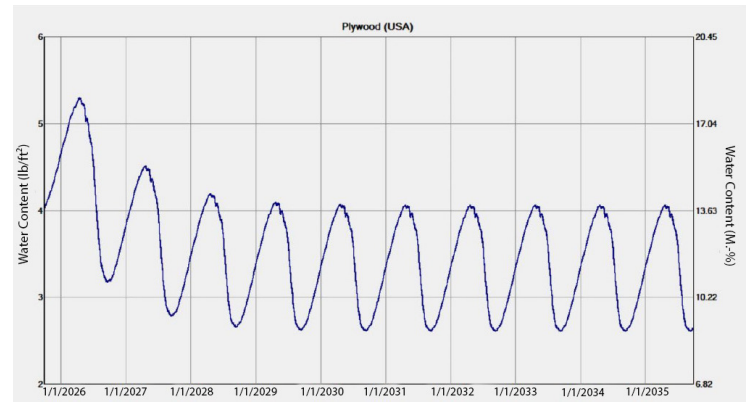
**Ice Barrier Membrane**

The ice barrier membrane assembly took longer to stabilize, and at a higher moisture level (3.7–4 lb/ft<sup>3</sup> within 1 year).

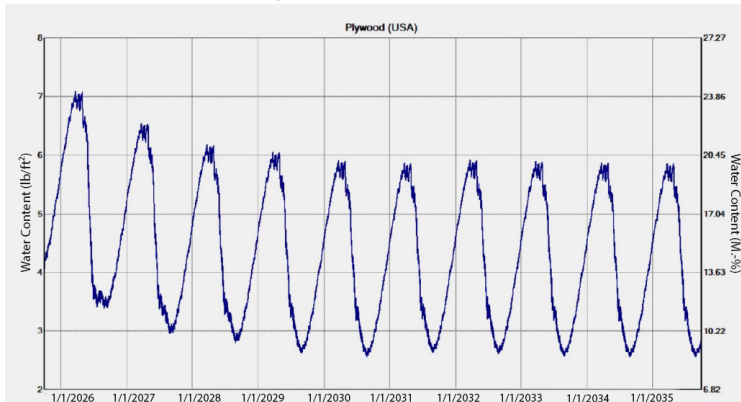
### SlopeShield Plus SA

*SlopeShield Plus SA showed progressive drying, down to safe levels (below 8.25 lb/ft<sup>3</sup>).*

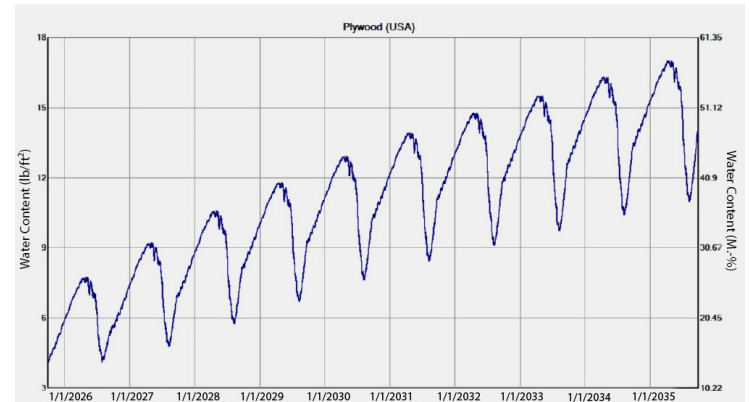
### Ice Barrier Membrane

*The ice barrier membrane showed ongoing moisture buildup. Reaching 10.5+ lb/ft<sup>3</sup> in Boulder and 17+ lb/ft<sup>3</sup> in Billings by year 10, with no sign of reversal.*

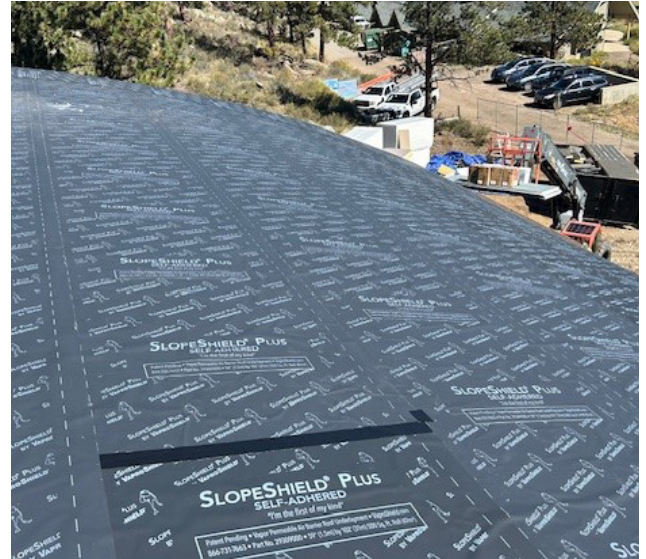
#### EAGLE ROCK HIGH SCHOOL

*Eagle Rock High School in Estes Park, CO, utilized SlopeShield Plus SA roof underlayment under a barrel shaped metal roof system. Allowing for the roof assembly to dry in both directions.*
